# Case Studies in Veteran Tree Management

Examples from across Europe

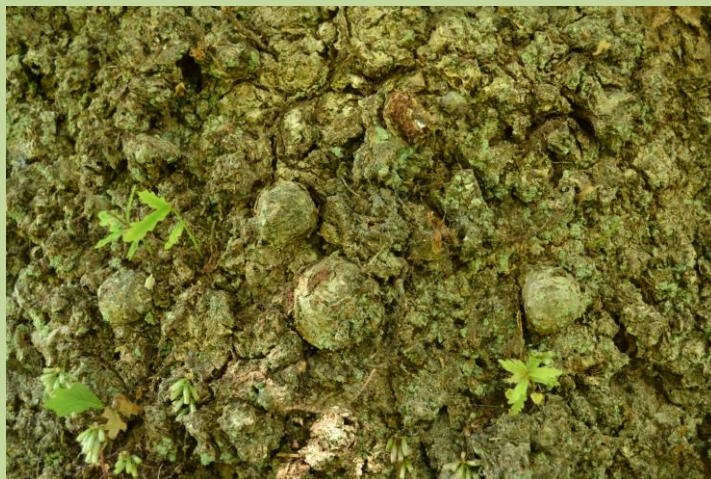
2016: appearance of new reiterations on the trunk and branches = The future of this veteran tree

- 2010: cut of half of the spruces allowing more light to reach the oak.
- 2012: planting of an apple orchard behind the spruce, in advance of felling, to protect the oak in the future.
- 2014: cut of the second half of the spruces,
- 2015: construction of props on three main branches and mulching at the base of the tree.

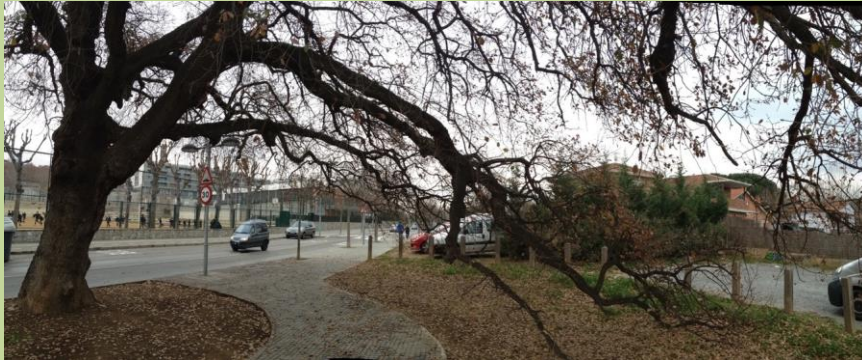
Description of the tree: Oak of "Can Farga". Old Oak, located in a urban environment. Spain.

Description of the problem: Some of the lower branches are bending low and there concerns that they will break

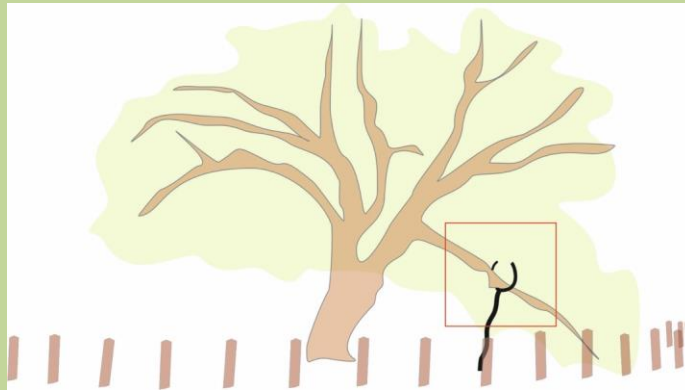
Sketch of the proposed intervention and the possible location of a prop.

Solution: Placing a dynamic support to avoid breakage of the lower branches. It is planned to make other 4 supports in the future for other branches.

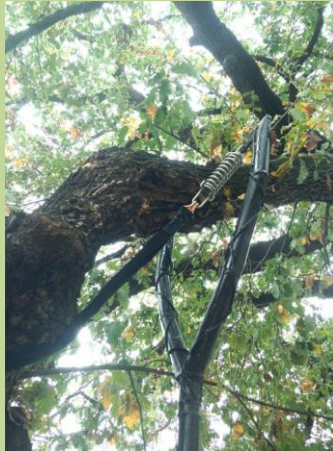
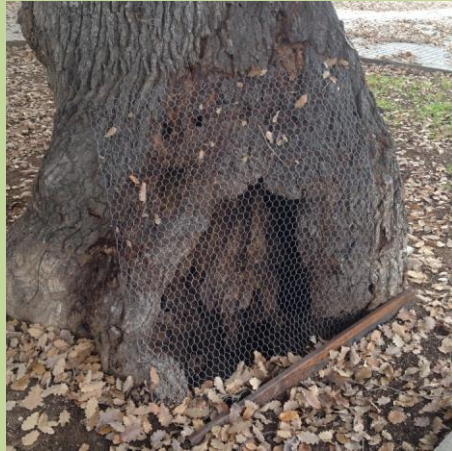
Solution: Detail of the first dynamic support for a lower branch

Small area at base of tree protected to prevent the accumulation of rubbish in the hollow trunk.

It's planned to make other 4 supports to add to the existing one.

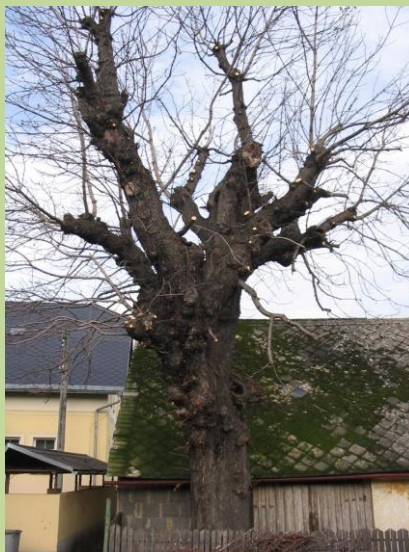
- *Aesculus hippocastanum* L.
- Between a **busy road and house**.
- Repeatedly reduced in the past.
- **Trunk and branch decay**

Description of the problem:

The tree is placed in stressful environment with a high frequency of pedestrian and vehicles.

In the past the tree has been reduced repeatedly.

In 1996 – pruning of secondary crown, installation of static cabling system to three main axis.

In 2004 – new secondary shoots damaged the roof, the cabling system was revised together with pruning and reduction of secondary shoots above the roof (see photos).

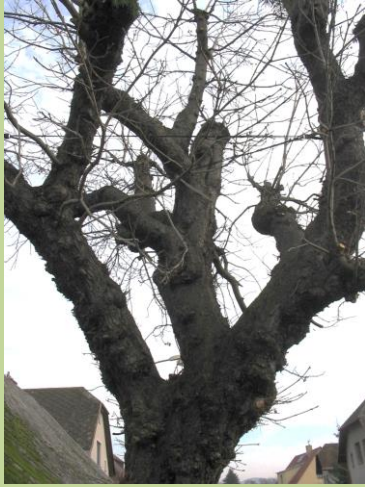
Photos after the treatment 2004.  
Cabling system of three main branches.

The previous (1996) cabling system was a combination of steel rope, metal components and synthetic straps. When checked in 2004 it was considered to be in good condition. However, according to current knowledge it should be replaced with static cabling and slip plates so as not to combine static and dynamic material properties and have smaller probability of ingrowth.

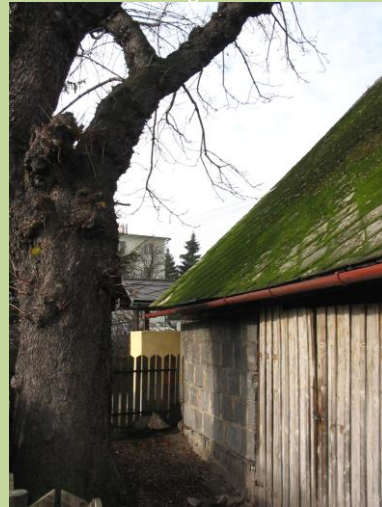
Photos after the treatment 2004.  
Reduced secondary shoots under the roof.

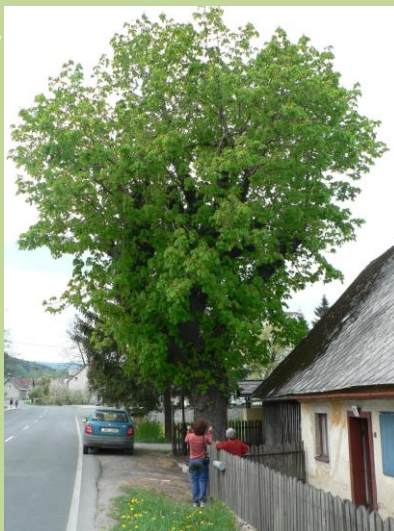
Tree assessment being carried  
out in 2007.

Tree was considered to be in good condition in 2007 and 2009 and further treatment was recommended – to prune the tree

In 2009 further  
treatment  
(pruning) was  
recommended.

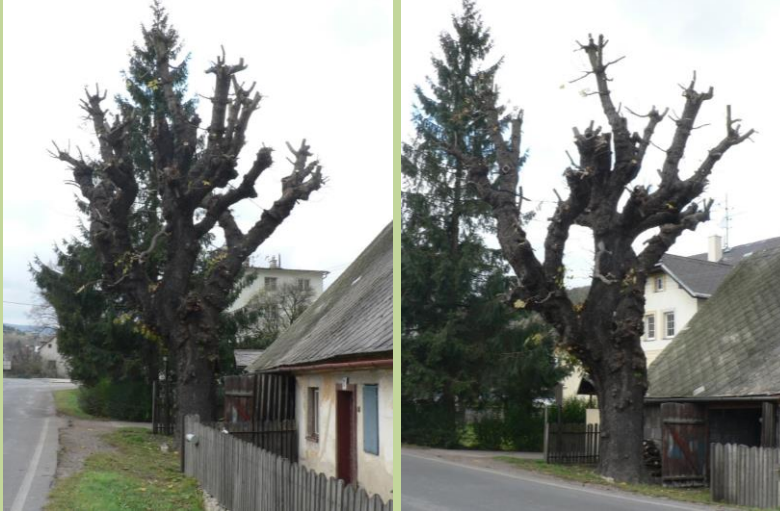
Pruning carried out in 2010. Reduction is now planned for every 3 years

Solutions (work carried out in 2010):

Tree reduction on 6 years of growth - the beginning of regular pollard management.

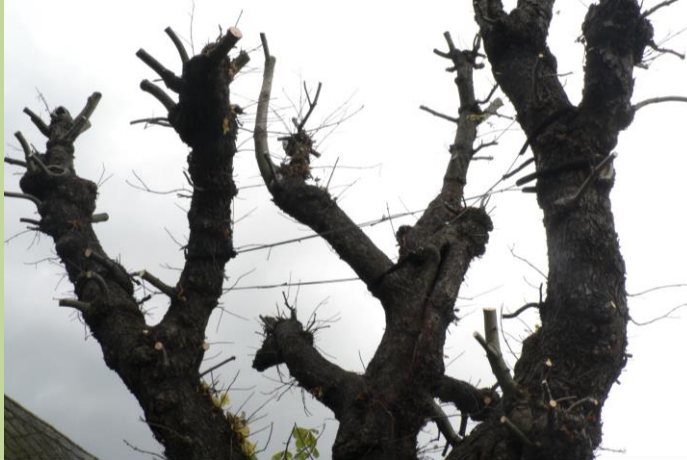
Cabling reinstallation in 2010.

The cabling system was reinstalled – a combination of steel ropes and textile case was used. According to the current standard this combination would be considered inappropriate but the arborist probably did not consider that this was a problem and replaced the original system. The shape of installation in the triangle is however considered to be appropriate.

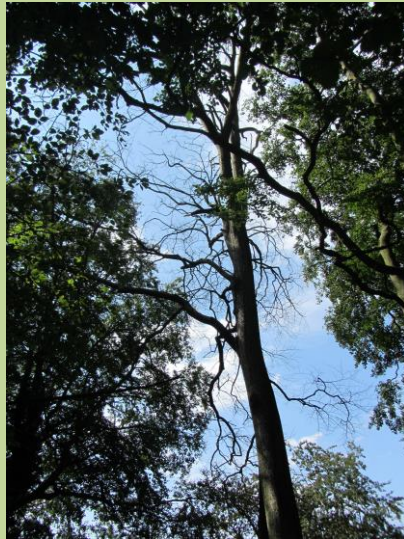
A beech tree standing within the grounds of a children's outdoor education centre died within a short period of time.

Concerns over the safety of the tree lead to a recommendation to remove it. Prior to removal the tree was subject to an aerial inspection for bats, during which bats were found in a wound on a branch.

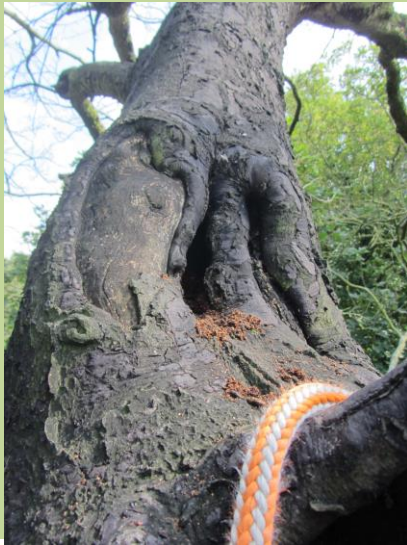
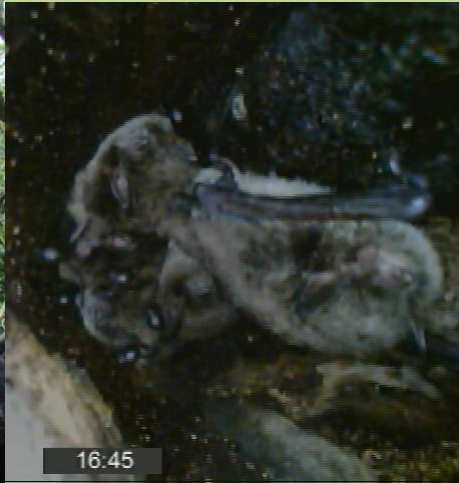
Picture of wound and bats in residence. Two species of bats were recorded using the hole at different times of the year.

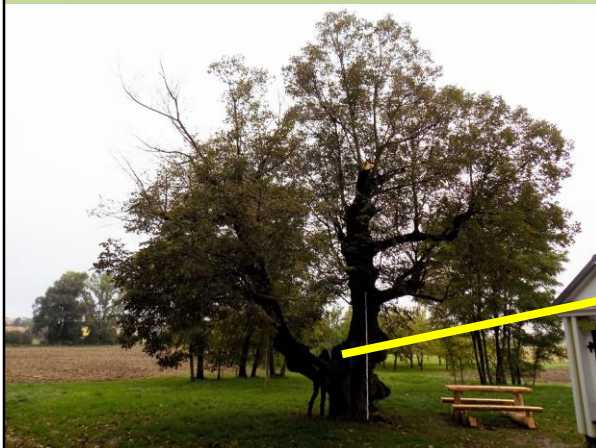
- *Tilia cordata* L.
- Heavy reduction during past management
- **Extensive decay** in trunk after branch breakage - connected to one of the side main branches.

- Tree base damaged in the past

The base of the tree has been damaged and had material piled against it

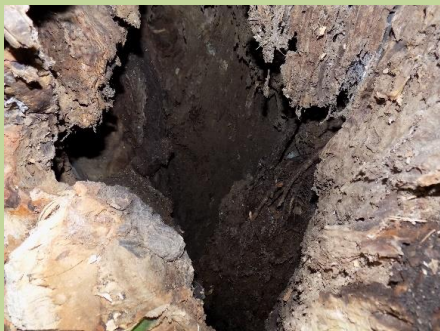
**Extensive decay** is a valuable part of tree habitat, but it may increase the risk of failure of a side branch.

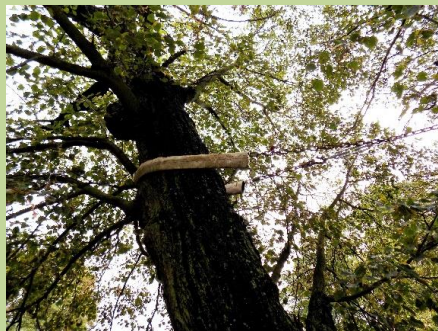
**Old static cabling system** – The chain (in a textile protective case) is not functional as it is loose. It does not stabilize the weak forks.

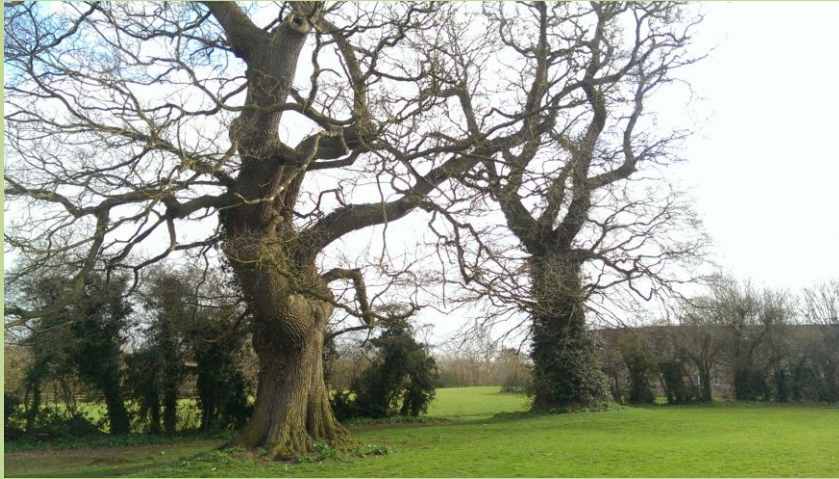
Two large oak trees in a public park in the UK. Report of a man living in the tree who had been excavating at the base.

- One tree was found to have an opening and cavity that several people could climb into, the extent of the hollowing was assessed, the t/R ratio was found to be approximately 1/5.
- The second tree had *Cerioporus squamosus* (syn. *Polyporus squamosus*) fruting bodies evident at top of stem near a bifurcation. A tomograph was undertaken at base the of the stem and it was found to be hollow.
- The ground around the trees was compacted due to footfall and use of ride-on grass mowers.
- There was a well used footpath next to the first tree.

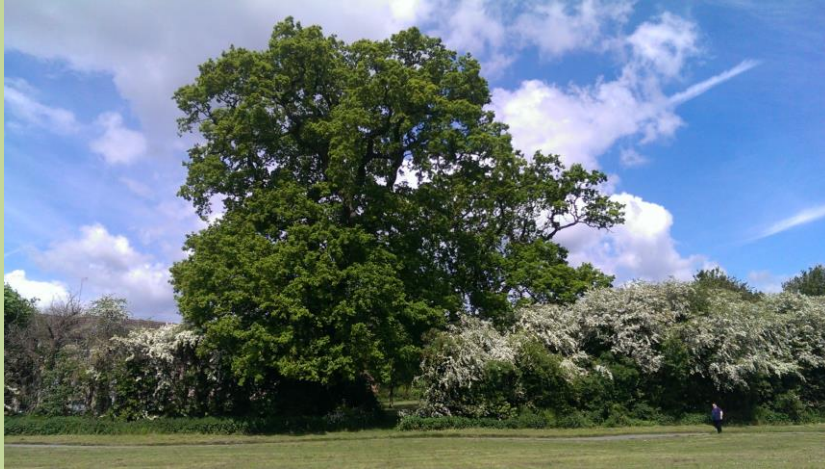
Description of problem:  
Footpath beneath tree

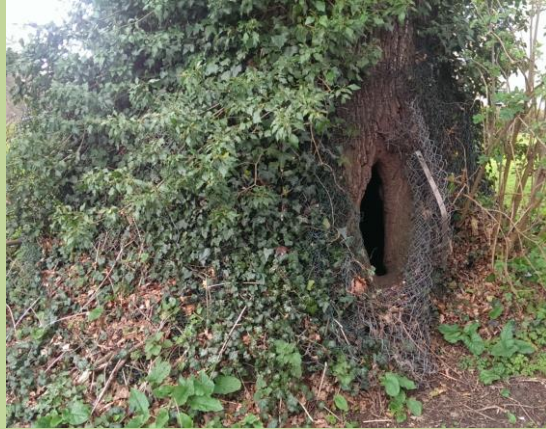
- Tree cavity at base could be climbed into.
- This tree was the focus of some anti-social behaviour.
- The t/R ratio was approximately 1/5

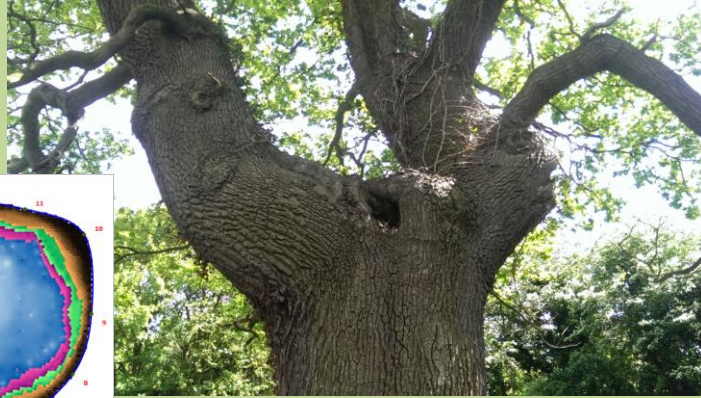
(@ 50cm above ground level)

The tomograph undertaken near the base of the tree showed that the tree was mostly hollow. A column of decay extended to where the stem bifurcated at approximately 3.5m. *Cerioporus squamosus* (syn. *Polyporus squamosus*) fruting bodies evident in a cavity at top (see photo) .

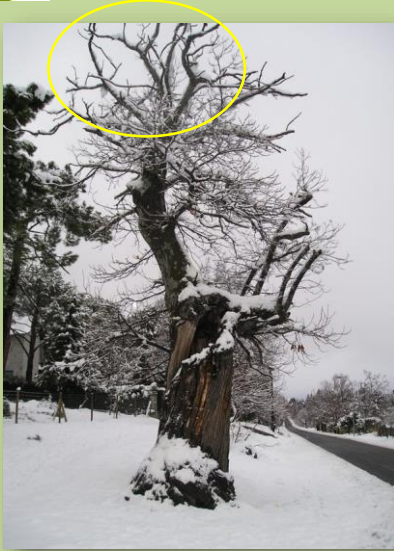
2009: Two crowns could be seen on the chestnut. The upper part was from the original crown and was completely dead but had no tears or splits.

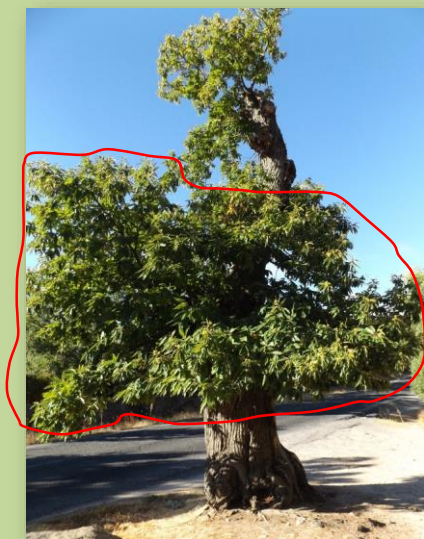
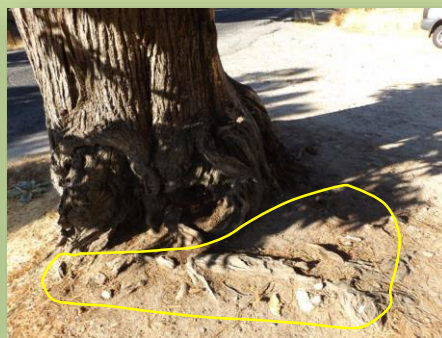
2015: Lower crown in development phase (red) and ancient exploratory roots dead and damaged by trampling (yellow).

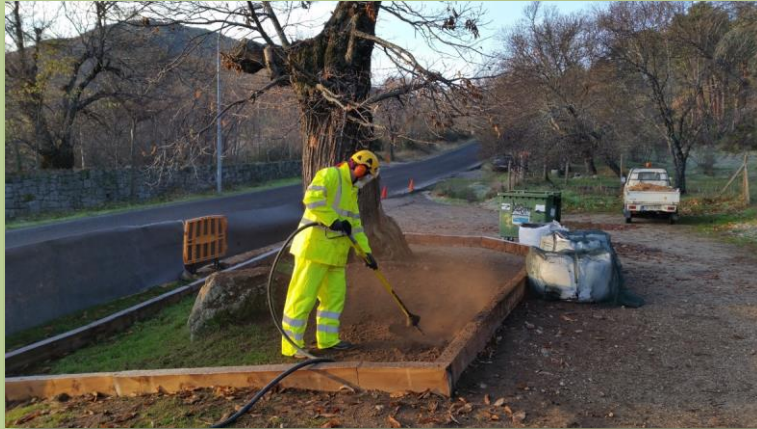
Start on 12/19/2016 an air spade was used to break up the Surface soil compacted after years of vehicles passing and people trampling.

Starting on 12/19/2016 an air spade was used to break up the surface soil compacted after years of vehicles passing and people trampling.

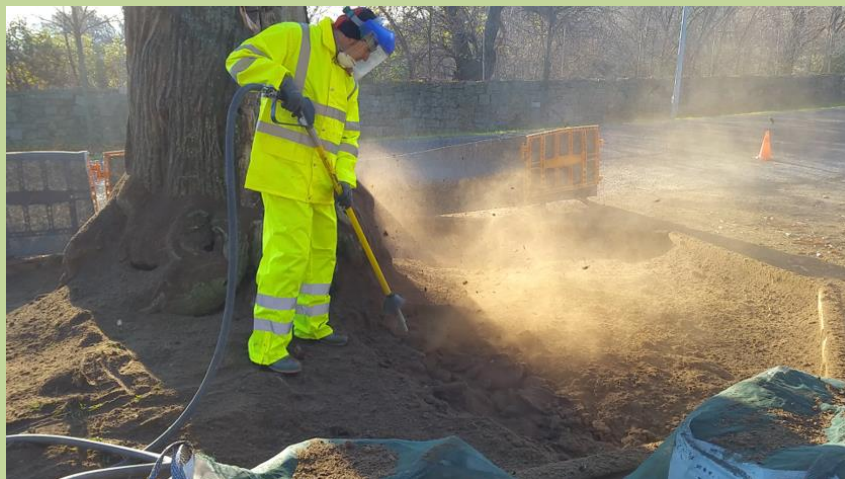
In this picture you can see how the hard pieces of 'soil' jump out

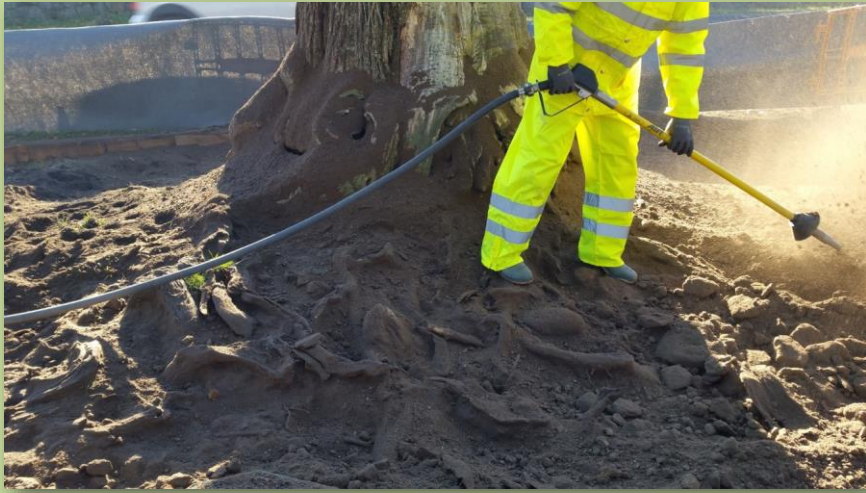
Observations during the airspade works:  
Ancient anchoring, exploration and colonization root systems on the ground are totally dead.

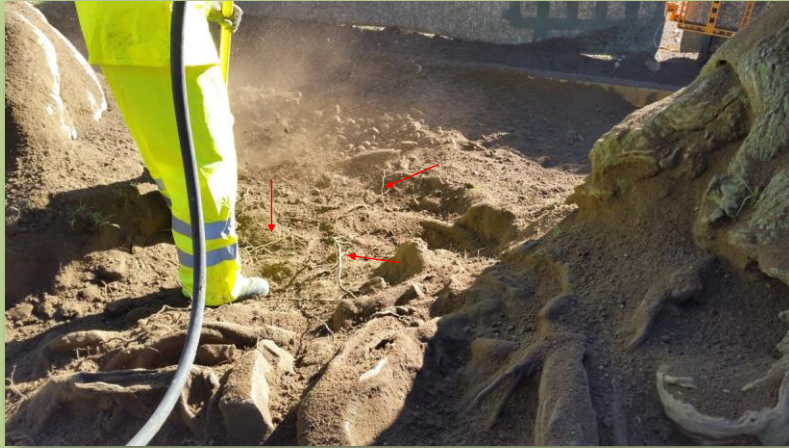
Small diameter roots for colonization and absorption were found in the area next to the road, just where we imagined they would be, where the vehicles did not pass and where the rainwater accumulated.

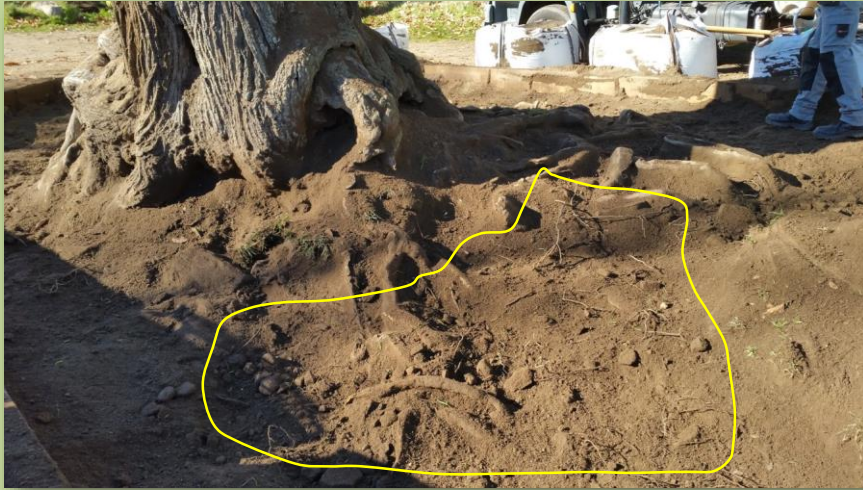
The main area of rootlets discovered (at an incredible 25 cm deep). Digging with the air spade did not go lower to avoid changing the characteristics of the soil and damaging the roots. From this point, the new layer of topsoil would begin to be added.

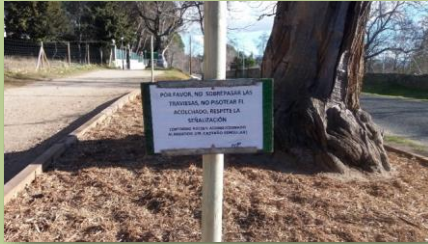
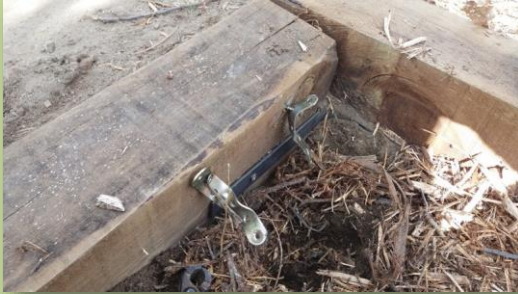
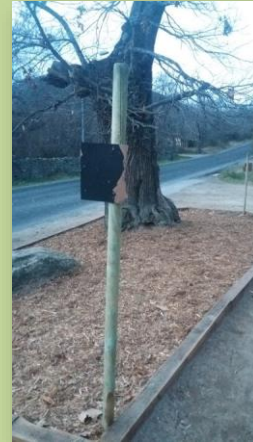
Less than a month after the completion of the work, vandalism was observed with breakage of the sign and disturbance of the mulch.

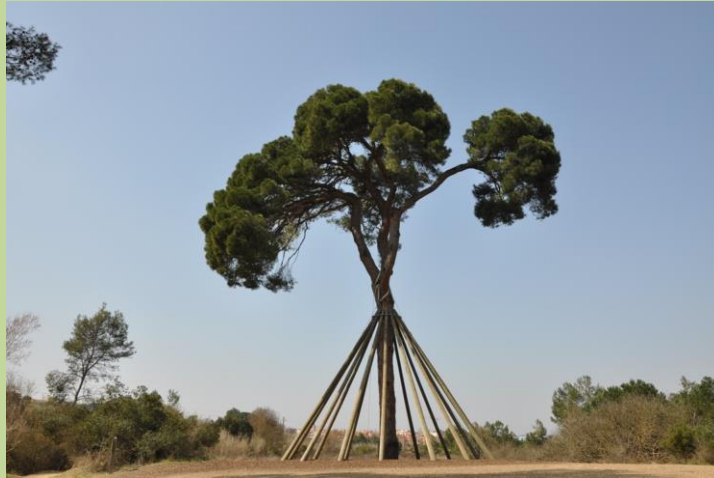
Description of the tree: The Pi d'En Xandri pine tree is a symbol of the city of Sant Cugat (Spain)

Description of the problem/issue: Real estate speculators attempted to cut the tree down by cutting the trunk at 80 cm from the ground.

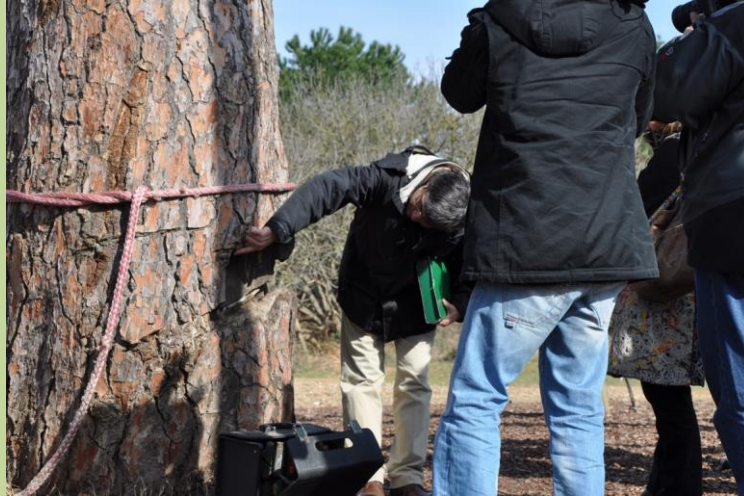
Description of the problem/issue: Detail of chainsaw cuts.
