# Case Studies in Veteran Tree Management

Examples from across Europe

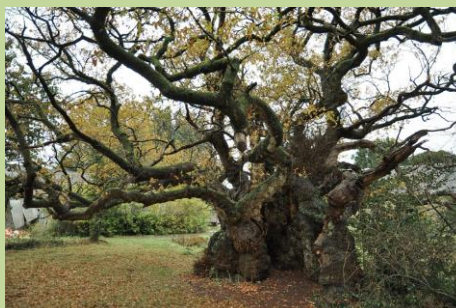
The study provides a set of potential objectives and identifies management options. The main problem identified was the neighboring trees, more than 20m in height (*Picea stichensis*), shading the oak. The lack of light causes the weakening of the colony of reiterations. To foster the resilience, the consultant proposed to bring light in, by cutting the spruces gradually.

In addition, two other problems were identified:

- mechanical fragility of several main branches,
- slight compaction of the soil by pedestrian visits

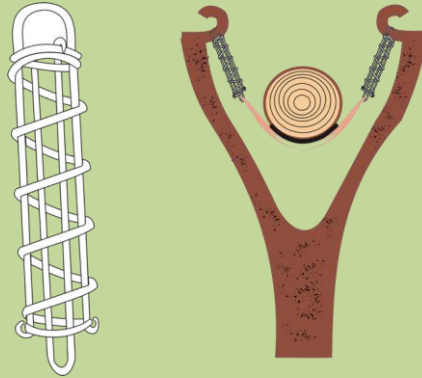
Description of the problem: Some of the lower branches are bending low and there concerns that they will break

Solutution: Sketch of the mechanism devised to prevent the branch from failing while still allowing the tree to move

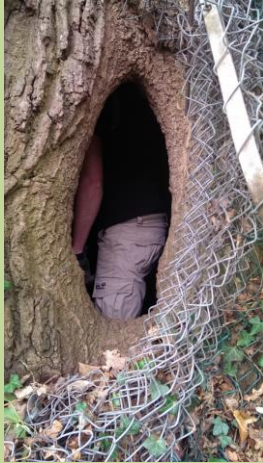
### Details of problem: Tree 1

- Tree cavity at base could be climbed into.
- This tree was the focus of some anti-social behaviour.
- The t/R ratio was approximately 1/5

The tomograph undertaken near the base of the tree showed that the tree was mostly hollow. A column of decay extended to where the stem bifurcated at approximately 3.5m. *Cerioporus squamosus* (syn. *Polyporus squamosus*) fruting bodies evident in a cavity at top (see photo) .

Trees were fenced and the footpath moved to reduce the likelihood of people walking underneath and therefore reduce the risk posed by these trees.

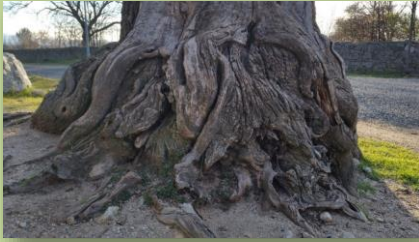
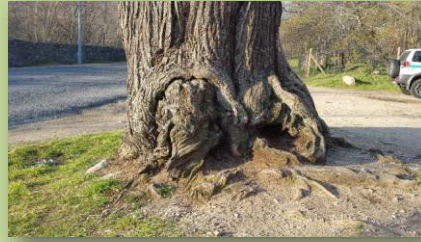
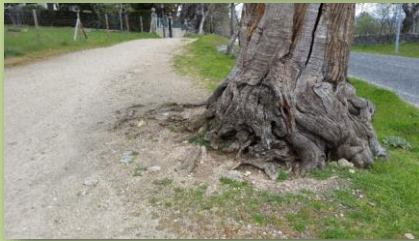
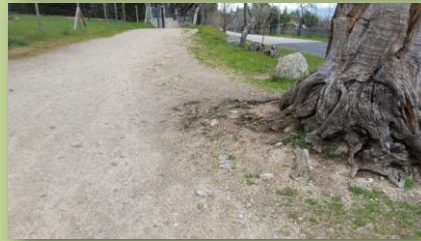
2015: Serious problems of compaction and the destruction of basal anchoring roots due to the use of the land around the tree for vehicle parking. Some of this occurred decades ago.

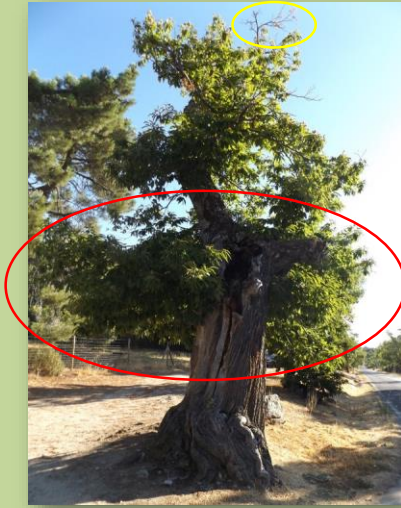
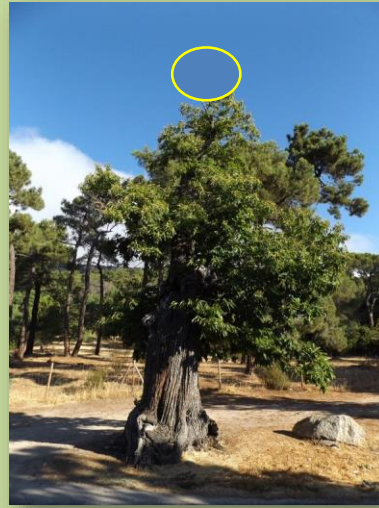
2015: The lower crown increases in size while branches are progressively lost in the upper part of the crown.

2015: Lower crown in development phase (red) and ancient exploratory roots dead and damaged by trampling (yellow).

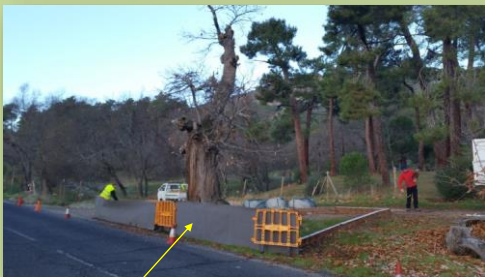
Under the surface the soil had the consistency of stone. When using the air spade, rock-like pieces jumped out.

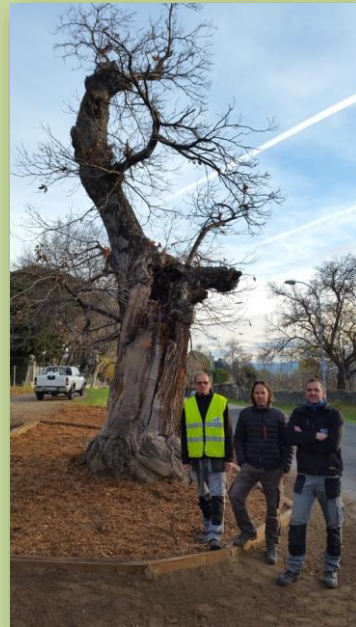
The addition of defibrated chipped wood was extended to a contiguous young tree

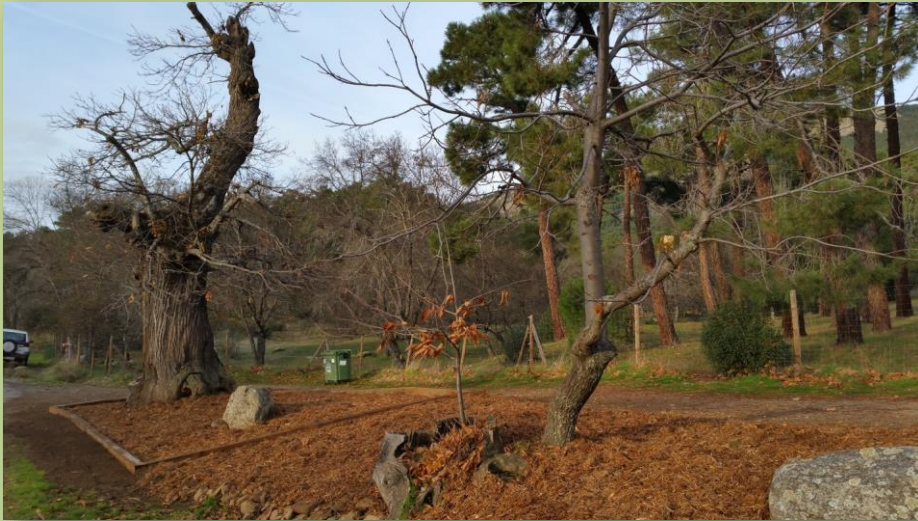
Third step:

The addition of defibrated chipped wood was extended to a young tree next to the veteran

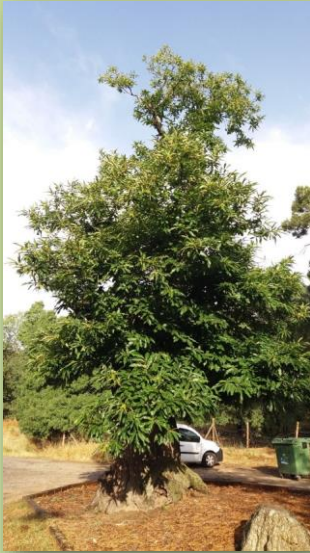
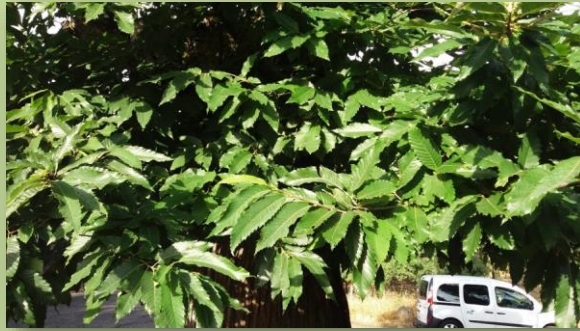
Less than a month after the completion of the work, vandalism was observed with breakage of the sign and disturbance of the mulch.

Sprouting of the year 2017 (July), the lower crown consolidates and increases in size little by little.

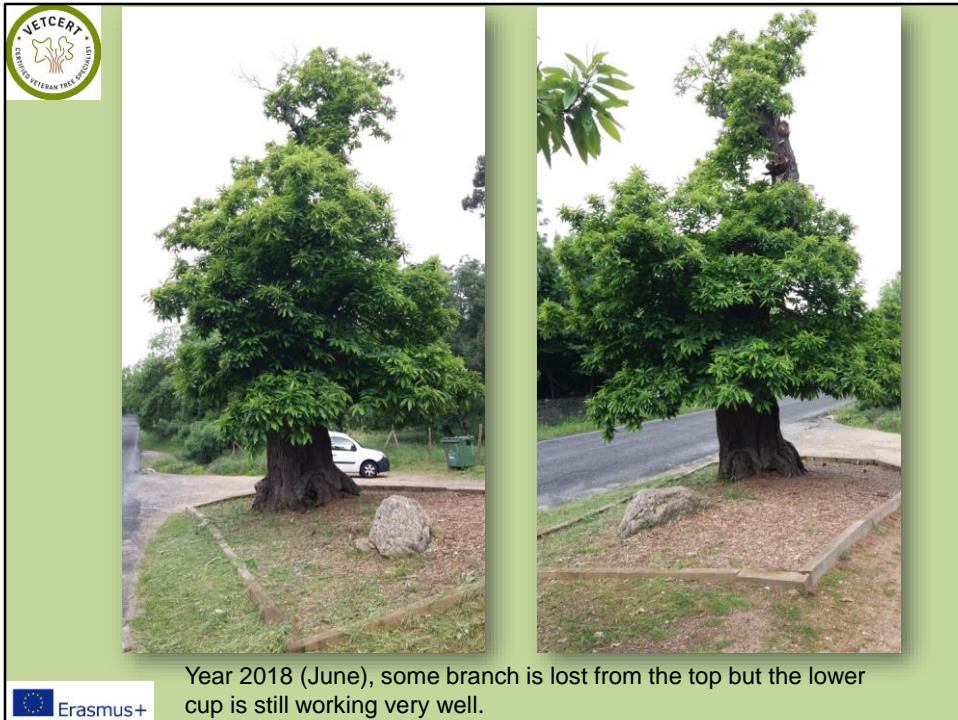
Sprouting in 2017 (July), the lower crown is consolidated and increases in size little by little.

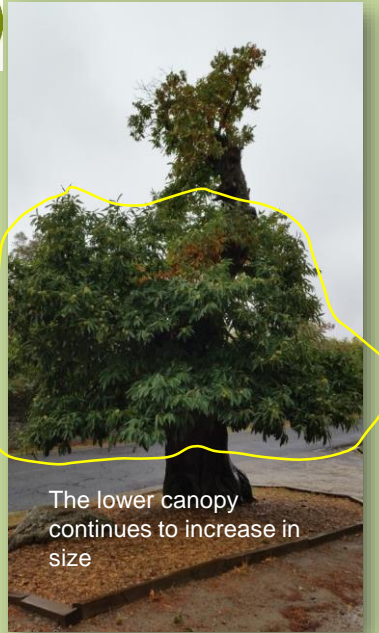
Year 2018 (June), some branches are lost from the top but the lower canopy is still growing very well.

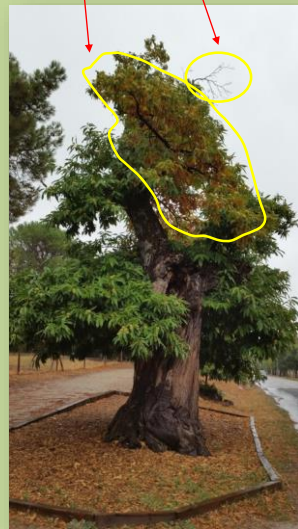
The lower canopy continues to increase in size

October 2018, two years later, with very good shoot growth in the lower crown (up to 20 cm in length), the tree progressively continues to retrench in the upper one. This autumn it seems that it is abandoning more branches in the upper crown and concentrating on the lower crown.

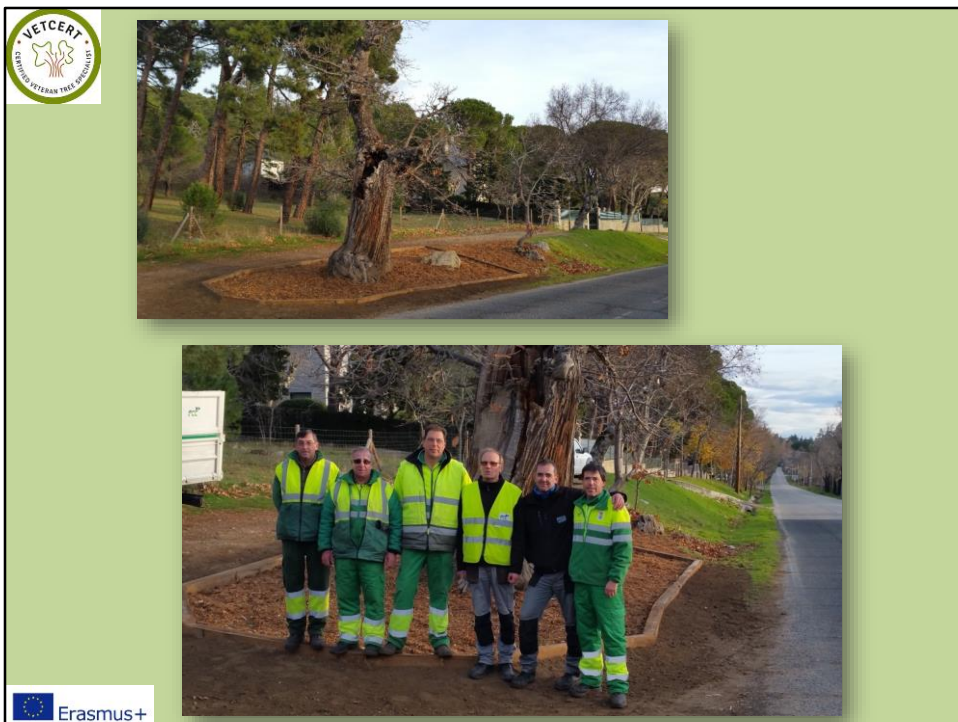
October 2018, two years later, with very good shoot growth in the lower crown (up to 20 cm in length), the tree progressively continues to retrench in the upper one. This autumn it seems that it is abandoning more branches in the upper crown and concentrating on the lower crown.

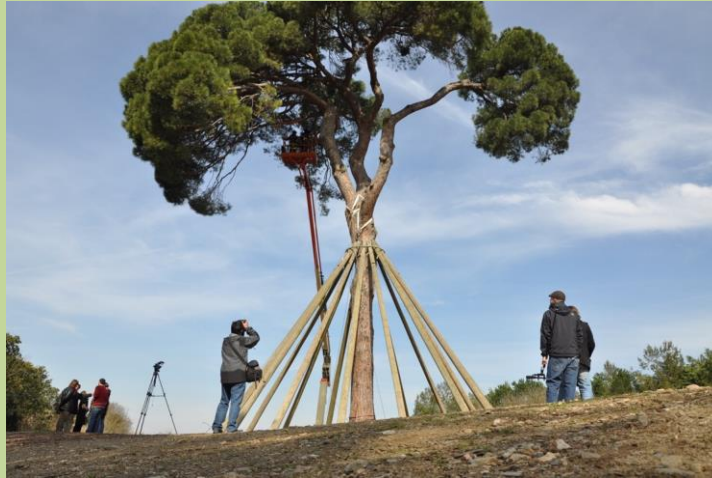
## Rescuing an old pine tree that developers had attempted to fell
